Sandy Lake Study and Action Plan for Water Quality Improvements

*Prepared By
Aquatic and Environmental Consultants
2005*

Sandy Lake Study and Action Plan

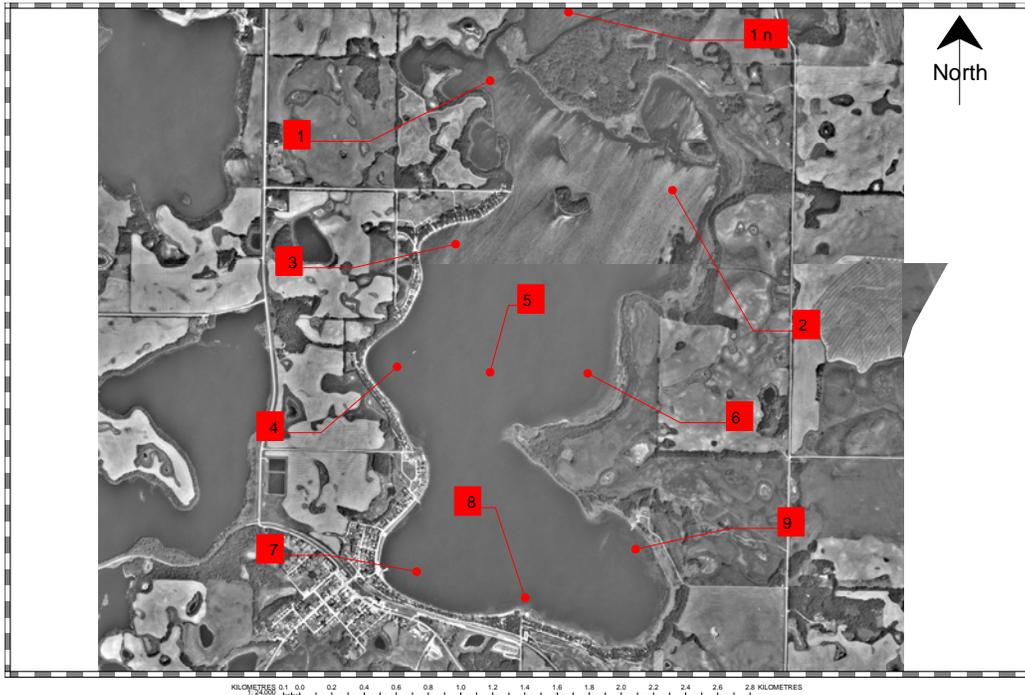
Figure 3: Water Chemistry and Benthic Sampling Sites

Field studies were designed to collect information that would further an understanding of the dynamics and health of Sandy Lake, as they related to the concerns and interests of the residents. The following surveys were conducted. Nine sampling sites were selected at the outset of the study in the south basin of the lake, with one site added in the north basin (Figure 3).

A minimum amount of benthic invertebrate work was done as part of the sediment gathering exercise for water chemistry (see below). Benthic invertebrates were gathered at stations 1, 5 and 8. While the exercise could not be described as quantitative, it never the less provided a qualitative listing of species found. All organisms were keyed to family.

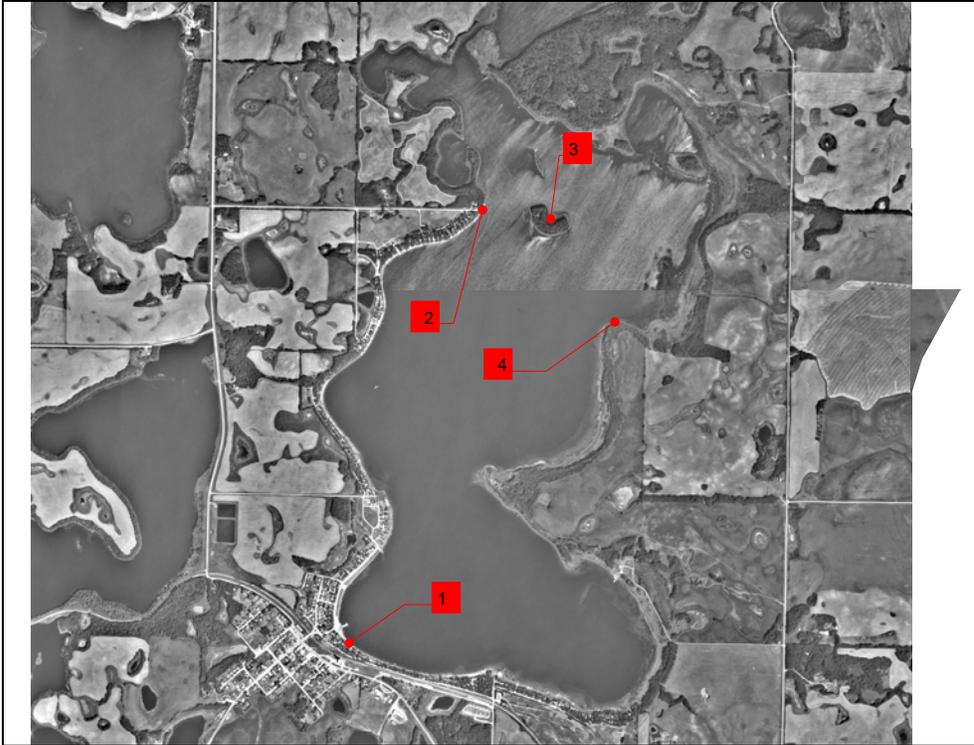
Figure 4: Seining Locations

Manitoba Conservation had undertaken a number of studies related to species composition on Sandy Lake, and this study did not anticipate repeating such studies. However, it was decided to gather information on small-bodied fish and spawning success by conducting beach seining activities at 4 locations on the lake. These locations are shown in Figure 4.

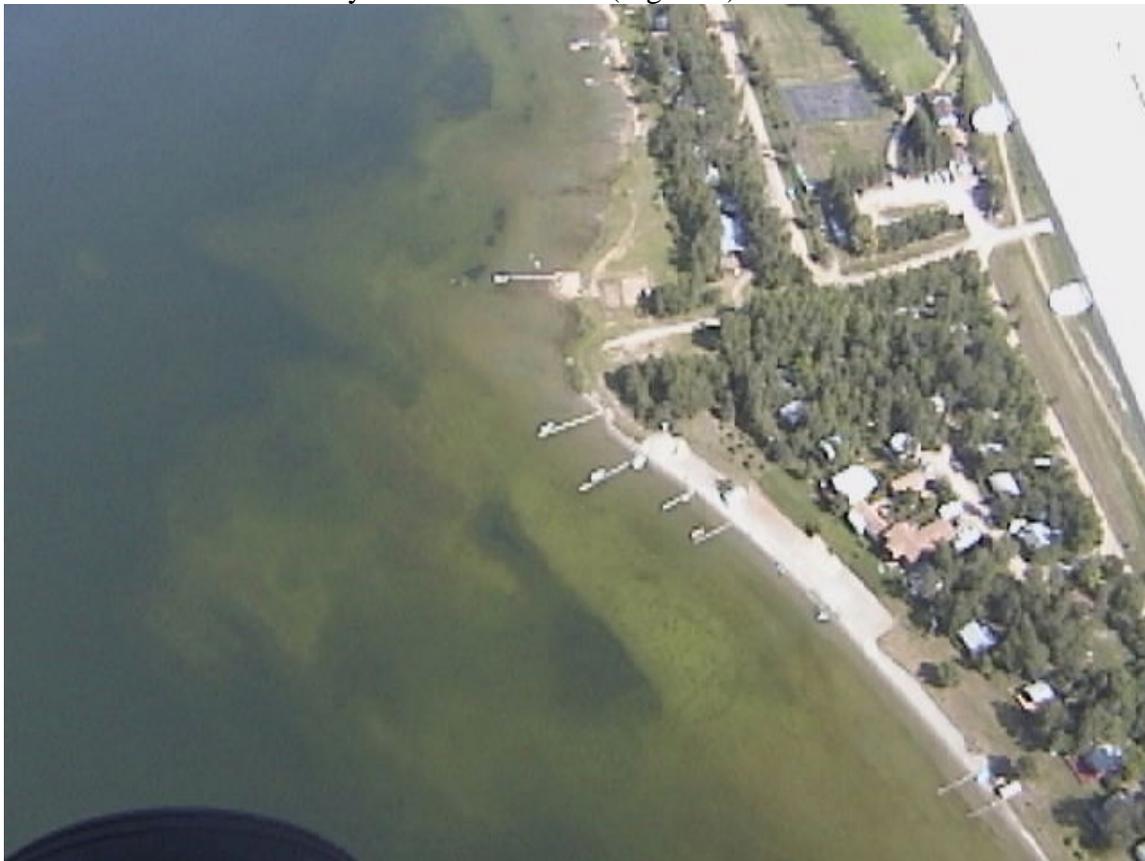
Figure 5: Aerial View of algal bloom on Sandy Lake

The aerial survey of Sandy Lake along with the boat survey and ground truthing provided the information necessary for developing the riparian assessment later in this report. The aerial survey was of particular interest in that it provided a clear view of the algal bloom that was of concern to many local stakeholders (Figure 5).

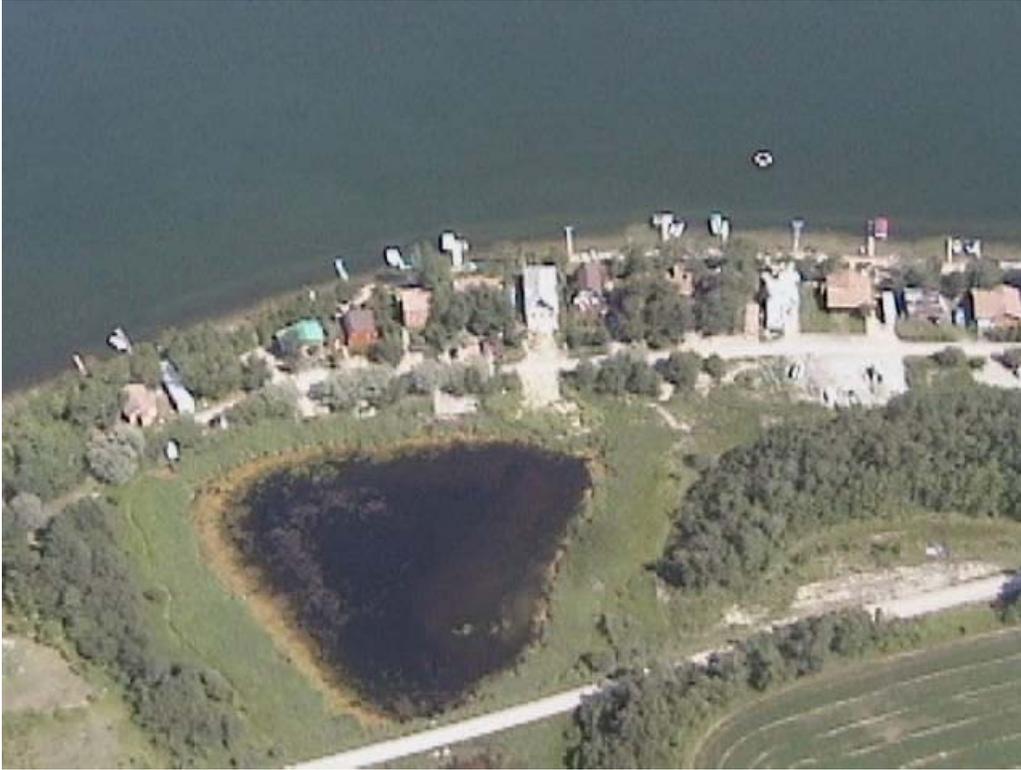
Figure 6: Cottage Density on Sandy Lake.

The video reconnaissance also provided an opportunity to observe any obvious situations that may have an impact on the water quality in Sandy Lake. It was immediately obvious how intensively utilized the lake was by seasonal residences (Figure 6). The area surrounding Sandy Lake was heavily used for agricultural purposes. Interestingly, only two relatively small cattle operations appeared to have any potential to impact the lake.

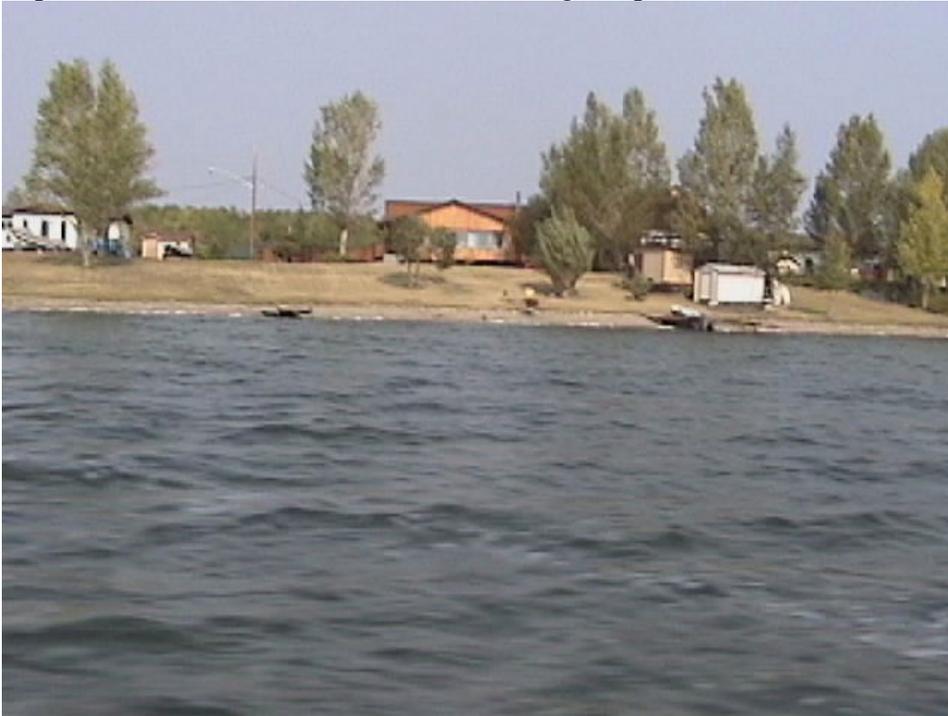
Figure 7: Lawns were extended to the edge of the lake

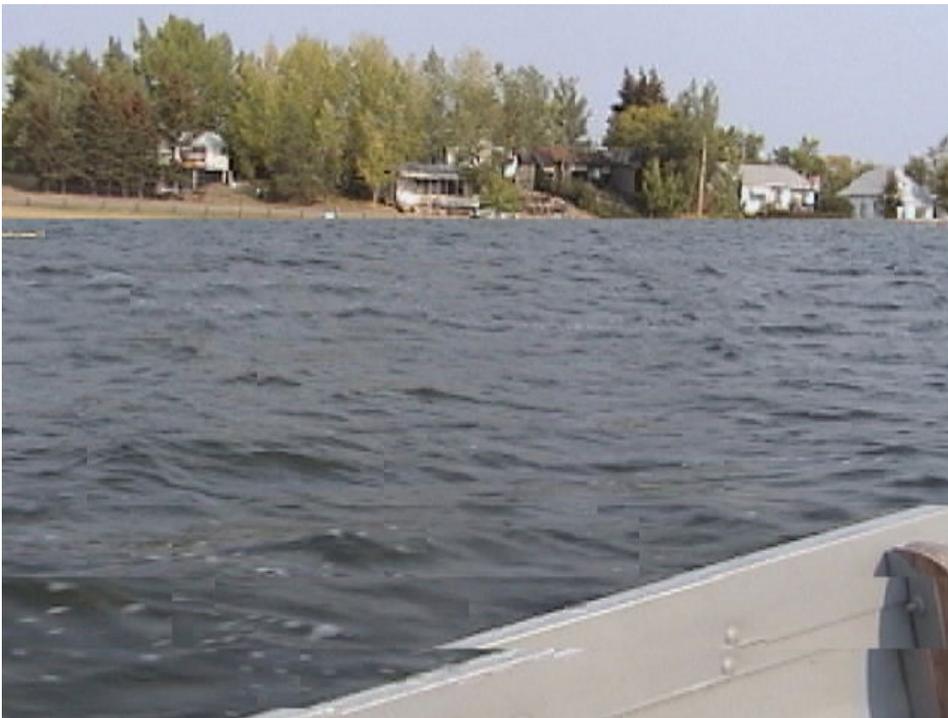
Figure 8: Some cottages attempted to maintain shoreline vegetation.

As previously mentioned, the riparian survey was completed using a combination of aerial and lake level video footage, and ground truthing. Assessing the condition of the riparian area was difficult, as much of the western shoreline and southern shorelines were completely developed. Of particular concern were areas where shorelines were cleared to the edge of the water (Figure 7) and areas where road development allowed run off to flow unimpeded to the lake. Such areas were rated as highly impacted. Areas were rated as medium impacted where at least a degree of shoreline vegetation was maintained, and where some attempts at controlling runoff were made (Figure 8).

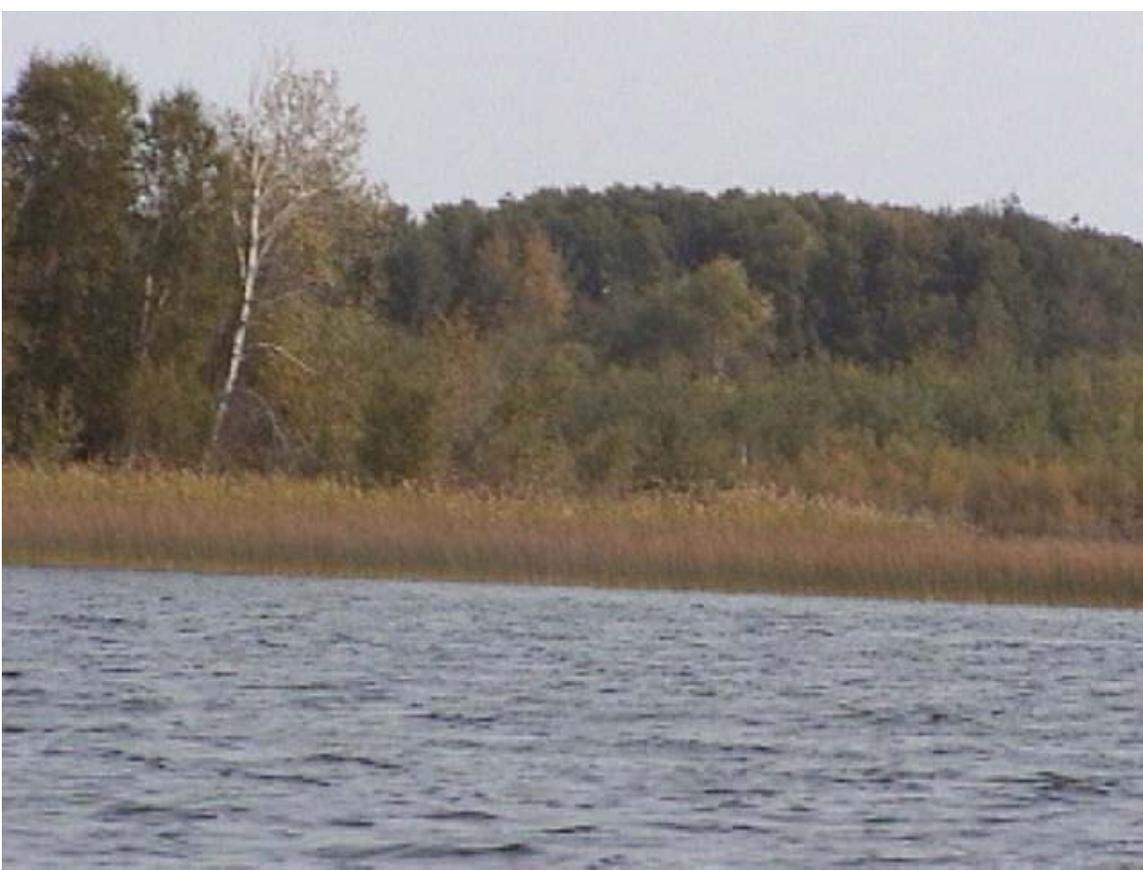
Figure 9: Natural Riparian Zones were present along much of the lakeshore.

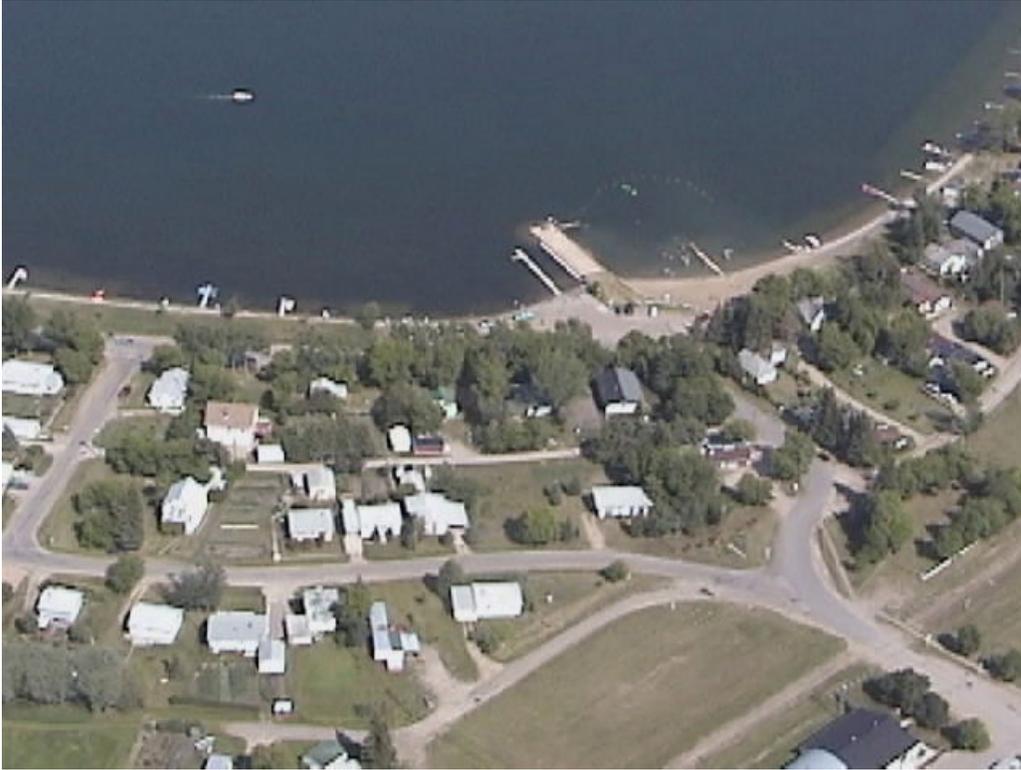
Figure 10: Main dock and access point.

Several issues were associated with the riparian zone. The main beach and boat launch area of the lake (Figure 10) was sloped directly to the lake. This allowed runoff from the town site to flow directly into Sandy Lake. Further, the municipal road ran for 0.6 km along the lakeshore, with no buffer zone between the road and water. At least two other roads on the west side of Sandy Lake also directly allowed runoff directly to the lake, with ditches facilitating the drainage. The golf course had one main ditch type drain constructed on the south east corner of the lake (Figure 11). This drain went directly to the lake. Along the southeast corner of the lake an agricultural operation had a small number of cattle, which had direct access to the lake. The landowner had fenced the riparian area off from the cattle, but had not yet provided off lake watering. This necessitated the occasional access via a gate to the lake by the cattle for drinking water. In all of these locations, the riparian zone was rated as high impacted. One other issue related to a small drainage ditch on the east side of Sandy Lake (Figure 12). This drained a series of small bogs and flowed across open field that appeared to be used for grazing purposes. Effectively, this drain bypasses the riparian zone, which in itself is rated as low impacted, and allows runoff directly to the lake.

As previously mentioned, the main access road to Sandy Lake beach and boat launch acts almost like a large drain funneling run off water directly into the lake. During rain events, water was observed flowing unimpeded down the road.

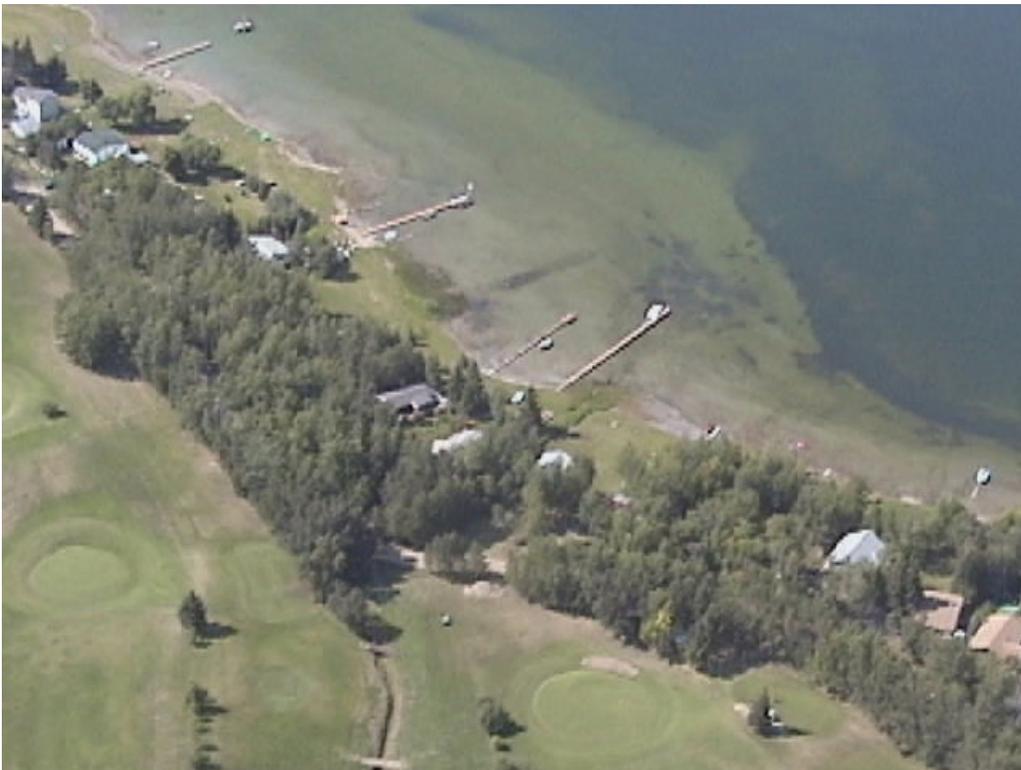
Figure 11: Golf course drainage ditch, visible in bottom center of picture.

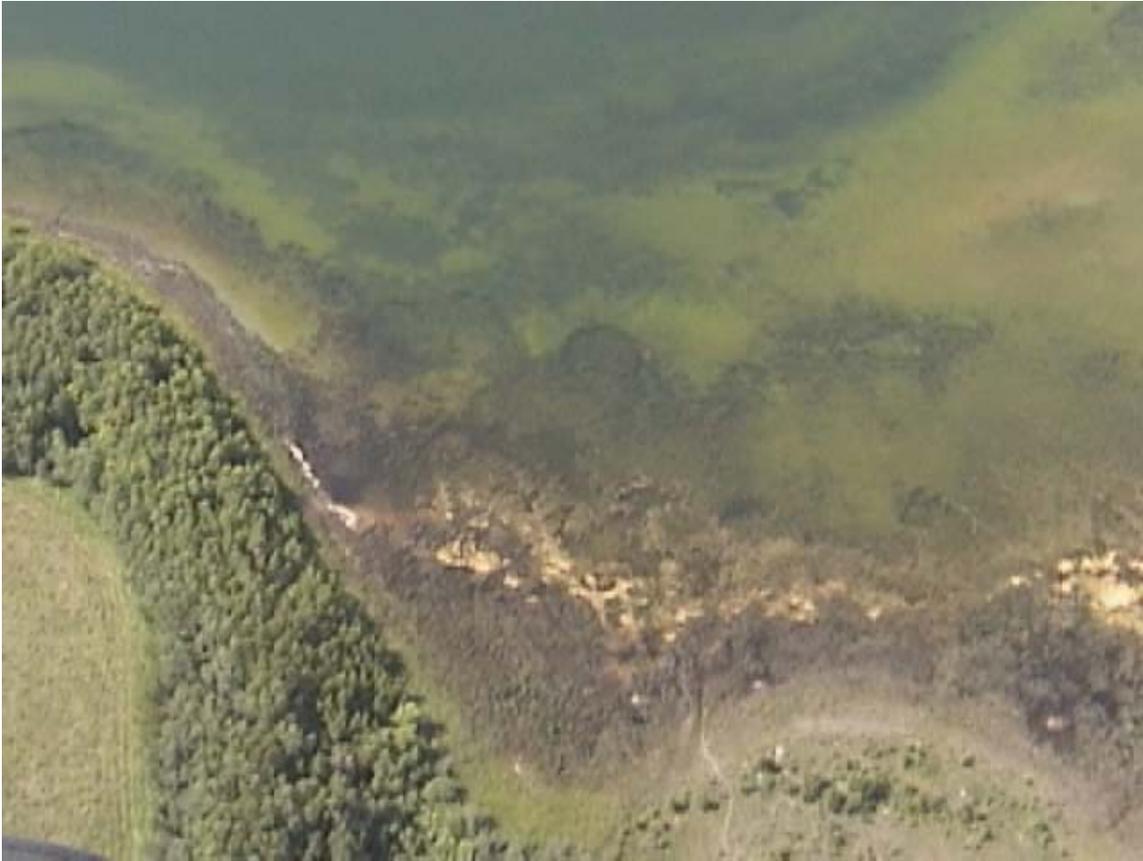
Figure 12: Overland drainage ditch along shoreline directly to lake.

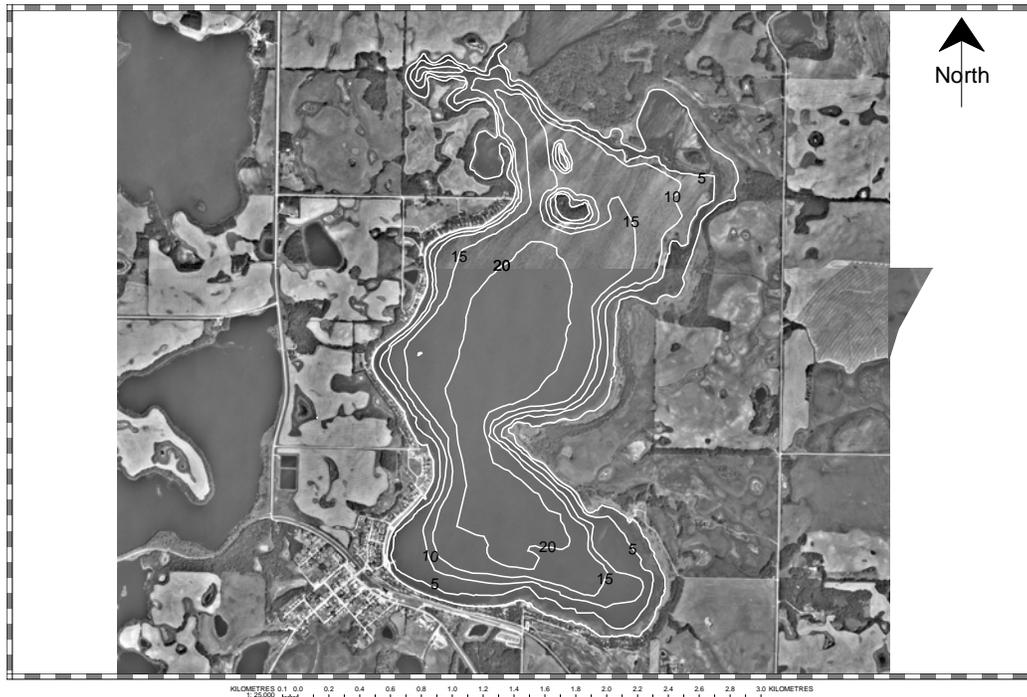
Figure 13: Contour Lines (From Manitoba Conservation, Mapping Branch)

Distribution of algal blooms and macrophyte production are controlled by two factors, namely the availability of nutrients, and the depth of light penetration. Within a basin such as Sandy Lake the light penetration is less affected by the water quality than by an algae bloom. These blooms tend to block light from penetrating and increase their production, thereby denying growth opportunity to rooted macrophytes. This of course makes more nutrients available for algae production. In Sandy Lake, light penetration (secchi disc readings) were unrestricted in the early spring, but reduced to 1.0 to 1.5 meters in the summer months. Aerial reconnaissance in August of 2003 was sufficient to produce a general distribution of the mid-summer dense filamentous algae bloom in the south basin of Sandy Lake. Depth contours (Figure 13) were closely matched by the distribution of the algae bloom (Figure 14).

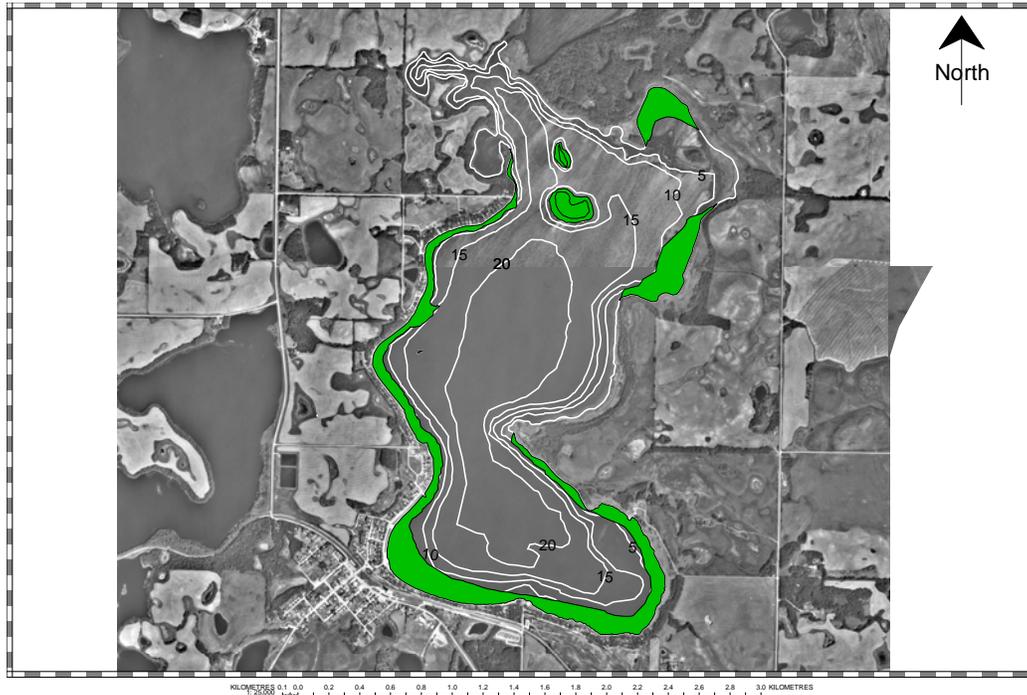
Figure 14: Areas of Algae Growth

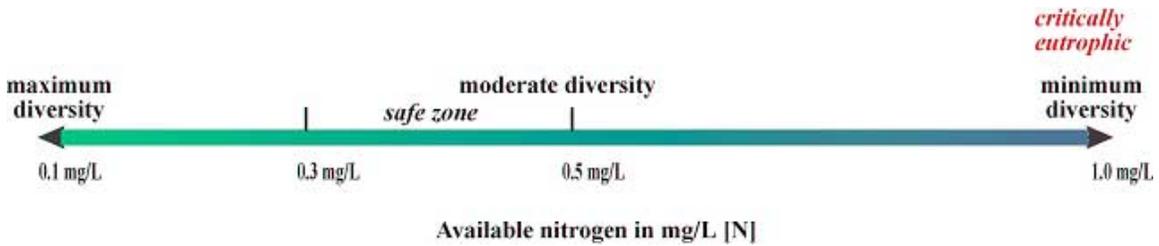
Figure 15 Relative eutrophication scale based on available nitrogen concentration

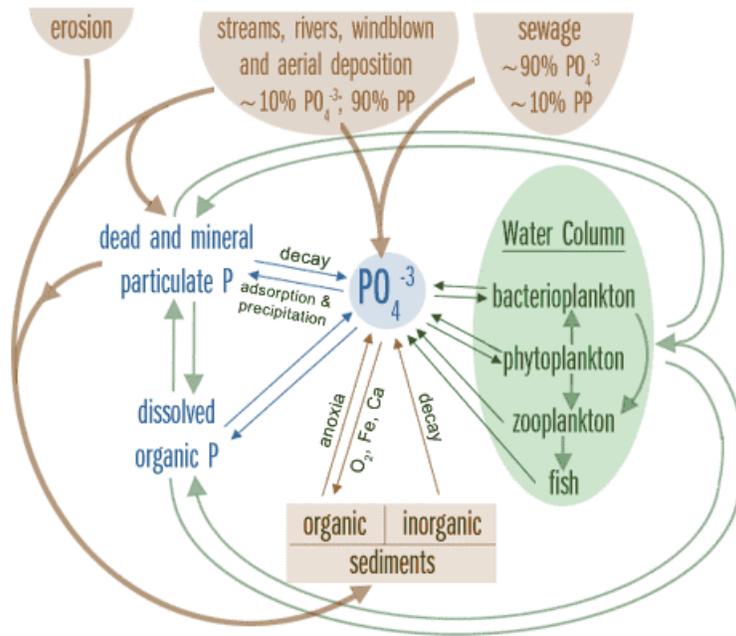
Figure 16: Phosphorus Cycle

The limiting nutrient to algae blooms in Sandy Lake was phosphorus. Sandy Lake has always displayed high nutrient levels, not uncommon with other prairie streams and lakes (Beck, 1985). The source of these nutrients is not known. It appears that phosphorus, once it is in Sandy Lake, becomes bound up in the sediments and is available for recycling in the environment. This cycle (Figure 16) perpetuates algae production.

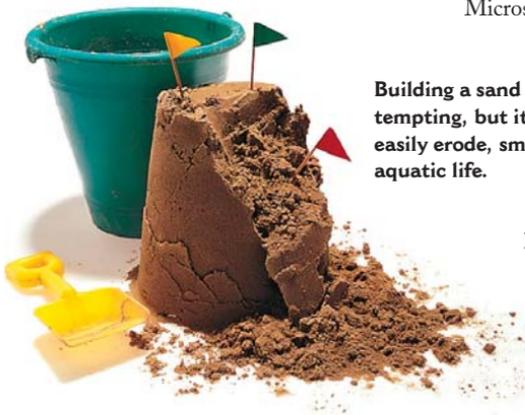
Building a sand beach is tempting, but it can easily erode, smothering aquatic life.

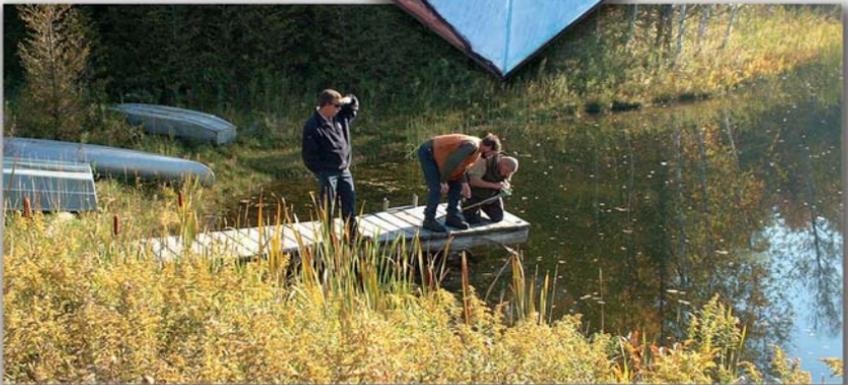
A Riparian Zone

Fortunately, the jumble of trees, shrubs, and grasses along a natural shoreline forms a "buffer" that helps filter out undesirables. In the *riparian zone* - the section of land closest to the shoreline - the thick layer of low foliage controls erosion and sifts impurities out of surface runoff. Leaves and branches break the force of falling rain, which is further slowed by the rough surface of leaf litter, pine needles,

and broken twigs. The water is then absorbed by plant roots or the soil. As well as being a filter for the lake, the riparian zone is a refuge for wildlife: water birds nest in the tall grasses near the water; and red-winged blackbirds flit among the cattails. When the area is flooded during the high water period, even if there is only 18 cm of water, pike will thrash their way over the spring-flooded banks, scattering their eggs in the lake-edge nursery.

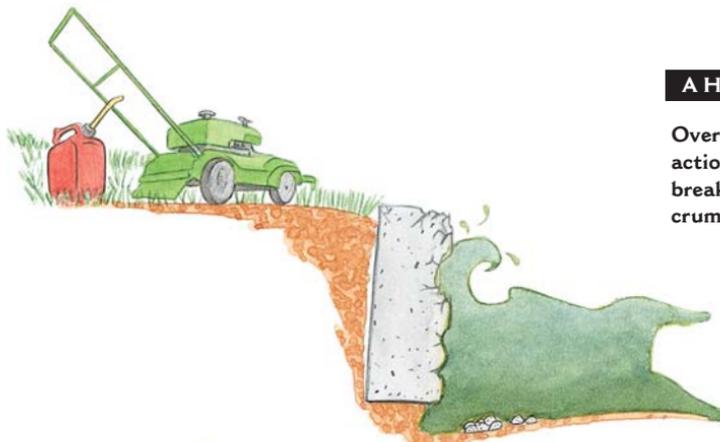
A HARD EDGE

Over time, wave action turns a breakwall into a crumbling eyesore.

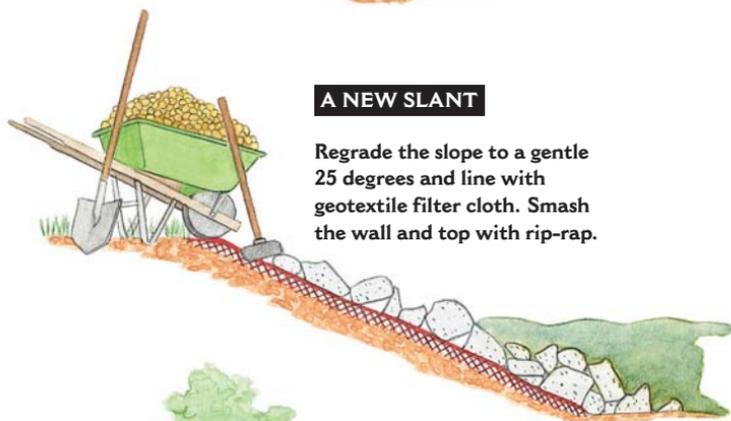
A NEW SLANT

Regrade the slope to a gentle 25 degrees and line with geotextile filter cloth. Smash the wall and top with rip-rap.

Ideally, you should remove the breakwall, but if that is not practical, you can pull it back onto the new slope and break the

concrete into cobble-sized pieces of rubble. Be sure to add a veneer of appropriately sized stones commonly known as “rip-rap” (usually 15-20 cm in diameter) to cover the filter cloth. Just behind the riprap, plant woody vegetation and shrubs, such as willow, dogwood, and poplar. Eventually, the plants will grow into the spaces between the stones. You will have a shoreline-friendly waterfront that controls erosion and provides wildlife habitat.
